Physical Characterization, Microstructural Evaluation, and Condition Assessment of Ancient Ahlat Tombstones in the Seljukian Cemetery of Ahlat (Turkey)

Tarik Baykara & Mehmet Cengiz Işık

Received 1 July 2015
Accepted 18 April 2016

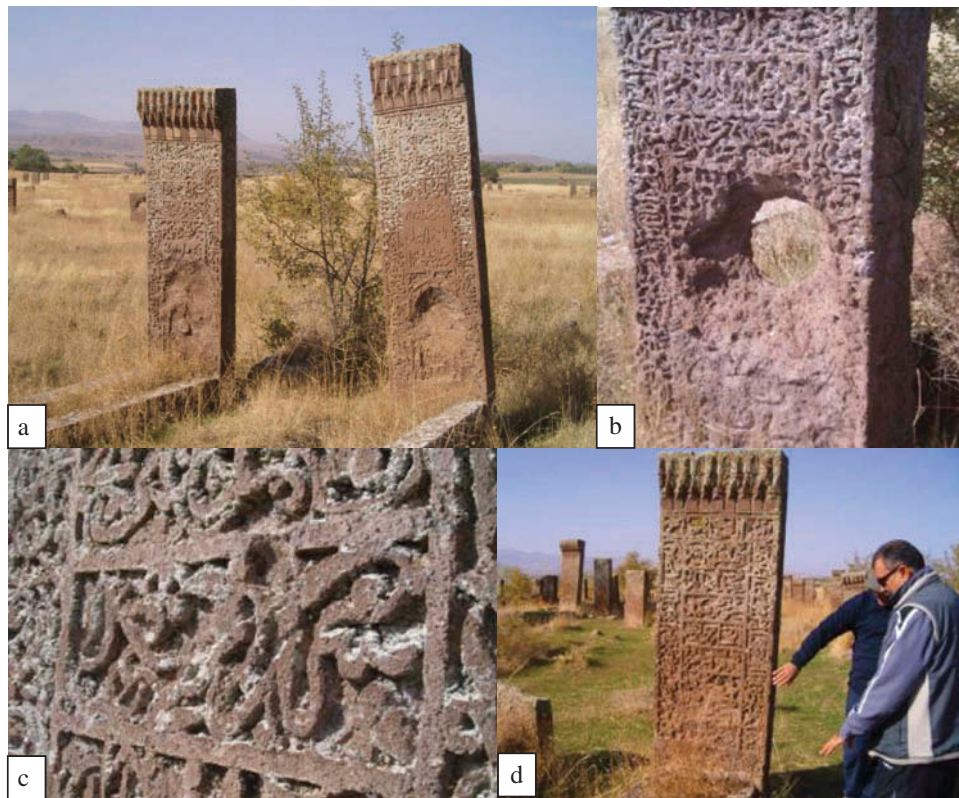
Figure 3. Structural deterioration, erosion at the center, and light yellow lichen formation starting at the top on the historical Seljukian gravestones of Ahlat.

These monuments (both gravestone “stelae” and cupola “vaults”) have not been analyzed and evaluated for preservation up to now. There is serious structural deterioration, erosion, and deformation, which can be observed on the surface of the stones, along with excessive lichen colonization, which starts from the top and partly penetrates the mid-sections of the stelae causing extensive deterioration and discoloration (typically light yellow and light brown) on the surface of the tombstones (Figure 3).

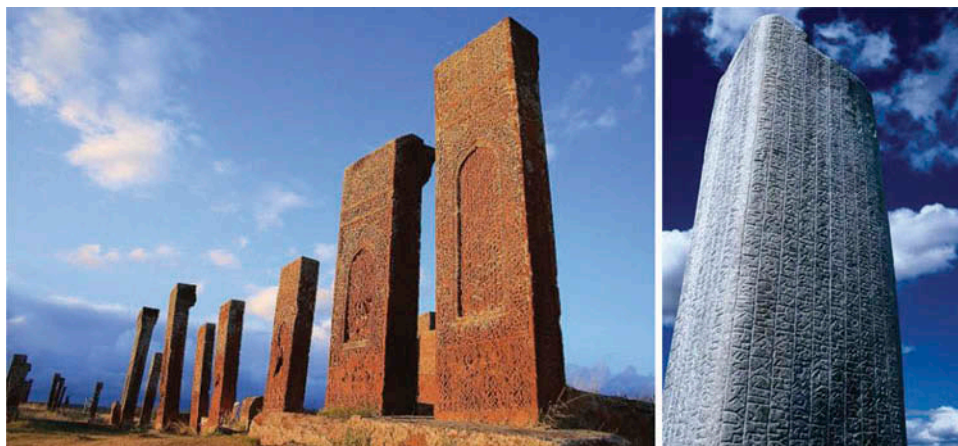
Orkhon Monuments” due to the resemblance to the Gokturkian Orkhon Monuments located in today’s Mongolia. The widely known “The Orkhon Inscriptions” are monuments erected by the Gokturks in the early 8th Century in the Orkhon Valley in Mongolia. These inscriptions are considered to be one of the very first Turkish constructions and the inscriptions relate to the legendary origins of the Turks (Figure 4).

Figure 4. (left) A view of the Ahlat stelae, and (right) a view of the Orkhon Inscriptions.

whole graveyard. As pointed out, the height of a stela was a demonstration of the status of the deceased, and most of the taller stelae are in better condition; possibly better quality stones were used for carving the motives and inscriptions (Figure 4 left). In this regard, one may also argue that lesser quality stones were used for the lower class and therefore their gravestones have degraded more than the others. The stones used in the graveyard were brought from different mines in the region, which may also explain the difference in the degradation mechanisms.

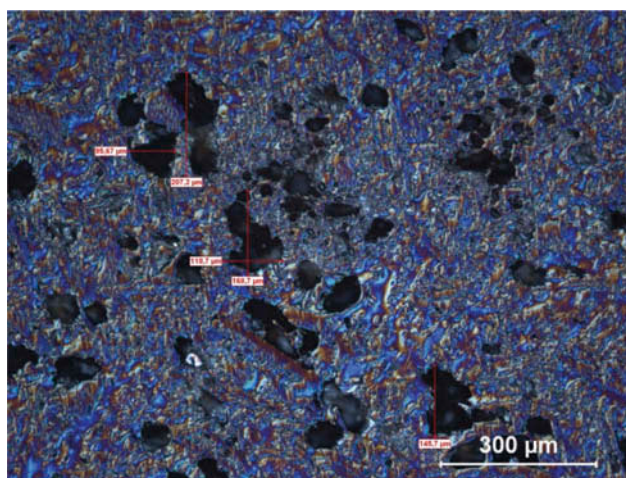
The photomicrograph given in Figure 5 shows pores with dimensions of 96–207 μm. Even though a detailed pore size and distribution analysis was not conducted on the samples, the pores within the interior section of stelae can be considered as “mesopores,” as in the case of the recently-quarried samples studied by Ozvan et al. 2015. Therefore, water capillarity is the major driving force, drawing water from the bottom section then expanding and distributing it toward the central portion of the structure. In this regard, the main mechanism of physical degradation, starting from the bottom up to the middle, is effective water capillary suction through the pores and channels in the structure.

Figure 5. Optical photomicrostructure showing pores in the interior section.

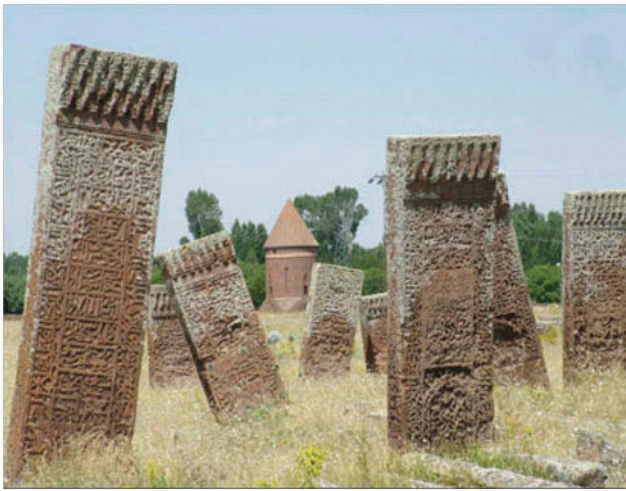
The view of the Ahlat Seljukian Graveyard, given in Figure 6, shows eight stelae along with a cupola (vault) at the far end of the view. Discoloration (light grayish color) due to lichen colonization of less than 50% of the surfaces starts at the top and descends toward the central section. In some stelae lichen cover more than 50% of the surface. As mentioned, in most cases spalling/flaking and erosion are observed in the mid-sections of stelae. In this regard, the deterioration and decay of the stones is due to complex mechanisms, simply outlined in Figure 7, including lichen colonization on the upper sections, spalling-erosion in the mid-sections, and capillary water/moisture effects starting from the bottom section.

Figure 6. A view of several Ahlat Seljukian stelae. Lichen coverage in lightly colored portions starts from the top and penetrates to mid-sections.

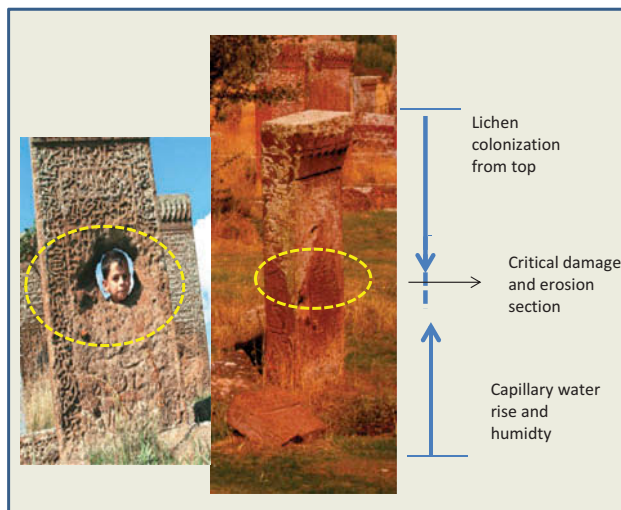
Figure 7. Degradation model of the stelae: Lichen coverage in lightly colored portions starts from the top and penetrates towards the center and capillary water uptake towards the centre.

- The lichen colonization and penetration (typically light gray/yellow and light brown colored layers) starting from the top and descending towards the central section.
- Capillary water absorption and moisture uptake approximately 25–60 cm from the ground to the central portion. There is no lichen coverage in these sections.
- Typically eroded and spalled surfaces at the center were observed in most of the stelae (critical damage and erosion section). The erosion and due spalling/flaking in this section is severe, and concave grooves, cratering, and eventual hole formation are detected in some stelae. Field observations revealed that most of the gravestones broke from these central locations (Figures 7 and 8).

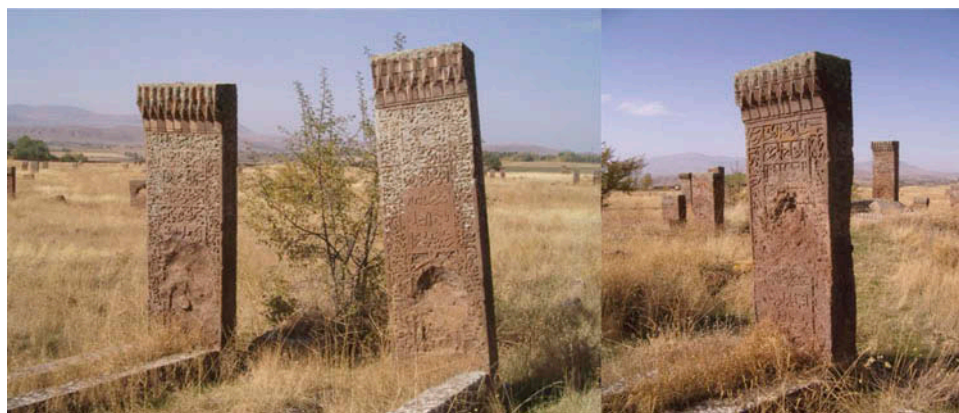
A close inspection of the surfaces of the stelae indicates this complex, multiple mechanism of deterioration and decay of the structural integrity. Each stela is covered from the top with lichen-fungi formations which diffuse towards the mid-section, and exhibit a variety of typical lichen colors (light gray/yellow and light brown). Most of the stelae exhibit a typical spalled-eroded concave groove and/or hole at the mid-section (approximately 25–60 cm from the ground). Folktales in the town explain that these holes and grooves are due to shell impacts of the Russian Army artillery that invaded the town for a very short time in 1916. Surely, this cannot be true as the hole formation is symmetrical (same conical grooves on both sides) and shattering and fragmentation from impact is not seen on the surfaces of the stelae. The big hole in the central section of the stela (Figure 7 (left)) is too large for the folktale to be true. However, the series of stelae in Figure 8 shows that the central sections with certain erosive features already in progress. Perhaps, a low quality stone might degrade faster and a large hole develop over time.

Being just a folktale and an exaggerated rumor it is, however, it is interesting to note that almost every single hole in the center of stelae is in the approximate identical location, indicating the capillary water level; there is no lichen coverage on these mid-sections. In addition, this central section also indicates the snow layer that remains for months during the winter. Climatic data, given in Table 1, indicates that around 130 days per year are below freezing point, the annual number of snow days is approximately 30 and snowfall is 30 days. The average snowfall height can reach 130 cm (source: www.ahlat.bel.tr). Cyclic freezing and melting of water carrying soluble substances (note

Figure 8. Eroded central sections of some stelae.

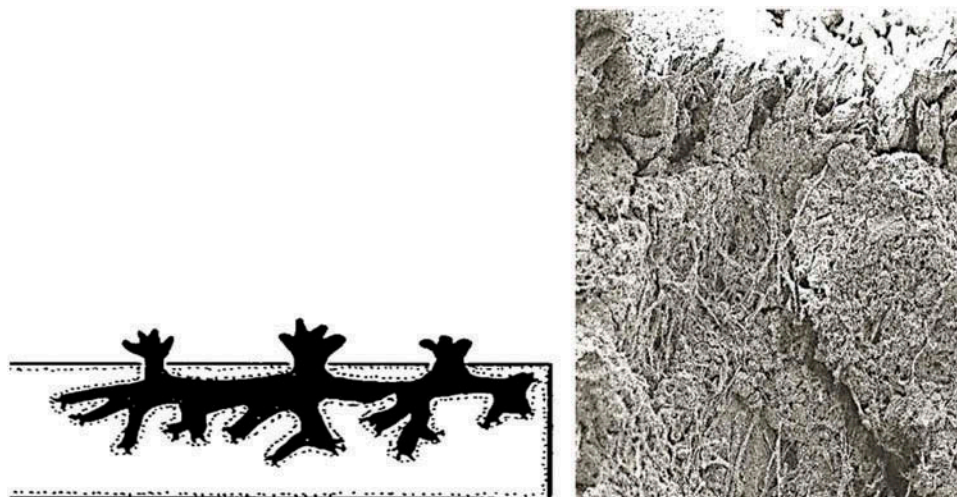
stelae decay, with a reservation suggesting the protective role of the lichen colonization. Extensive thallus penetration and the consequent network produced in the interior may provide a structural integrity to the surface. Another major problem for these stelae seems to be lichen layers filling in the finely and exquisitely carved ornaments, motives and inscriptions. Before deciding on the method of preservation and restoration, it is important to investigate the full characteristics of the lichens (formation, growth, and penetration) on the Ahlat stelae. The type of lichen, algae, and fungal formations, along with bacteria and other microorganisms, rate of growth, and resulting decay and/or protective role should be evaluated extensively. It is seen that the lichens covering the surface here are endolithic and that the thallus is completely immersed and penetrates deep into the substrate using pores, capillaries, cavities, and grain boundaries as pathways, Figure 10 (right).

Figure 10. Left: Endolithic lichens based on the forms of growth of thalli sketched in Lisci et al. 2003. © Lisci et al. 2003. Reproduced by permission of Lisci et al. Permission to reuse must be obtained from the rightsholder.

Right: Cross sectional view of Lichen-surface showing the penetration of thalli in an Ahlat stele.

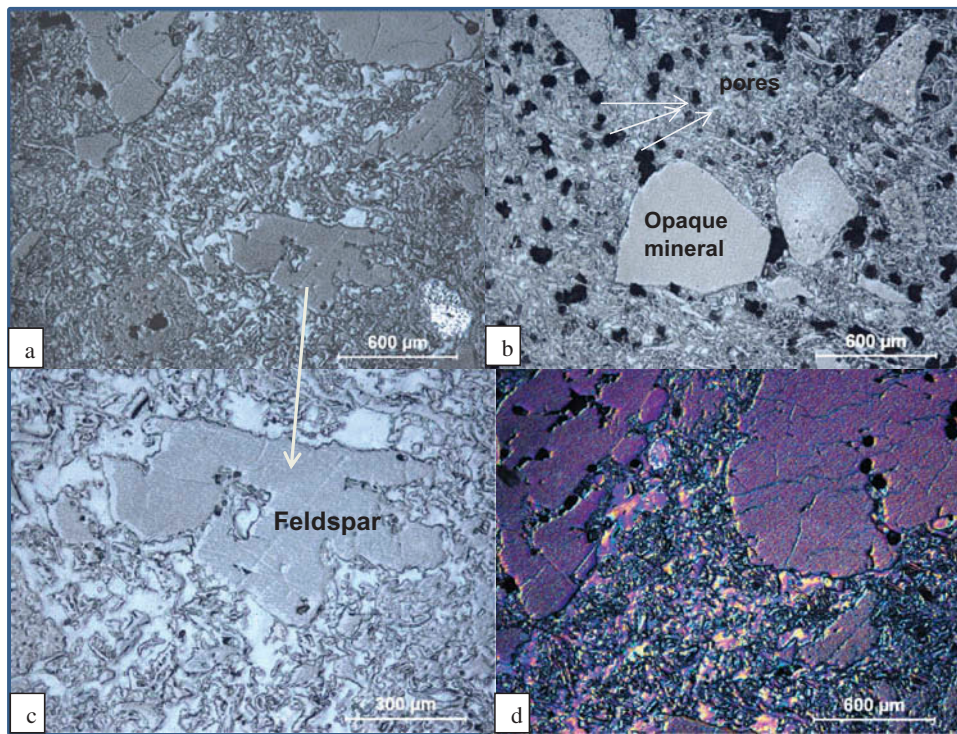
Microstructural examination of the samples revealed typical features containing plagioclase, sanidine, hornblende, volcanic glass, opaque minerals, and lithic fragments (Figure 11) similar to that of the recent study by Ozvan et al. 2015. However, the degree of welding is quite different from that of freshly-mined ignimbrite and distinctly poorer welding (i.e., loosely bound fragments) is apparent in all samples due to the effects of time i.e., more than 600–800 years.

Figure 11 shows optical photomicrographs of the interior. Irregularly shaped, 400–600 μm long feldspar and opaque mineral grains, distributed unevenly through a pumicous matrix constituting of pumice, volcanic rock, and glass pieces, and tiny lightly colored areas, depict the porous microstructure. The feldspar grains are fractured into pieces and cracks can be

observed within these grains. Holes, 50–60 μ m wide, both inside the feldspar grains and on grain boundaries are also present throughout the structure. It is obvious that such a porous structure with open holes and wide capillaries acts as pathways for lichen roots i.e., thallus. On the other hand, it should be noted that, thanks to such high porosity and hard grains of feldspar distributed in soft pumicous matrix, no significant cracking occurs on the stelae due to temperature fluctuation during any seasonal changes.

Figure 11. Optical photomicrostructural features of the interior region; large blocks of feldspar and opaque minerals are distributed within a very porous matrix. (a-c) parallel; (d) cross polarized light.

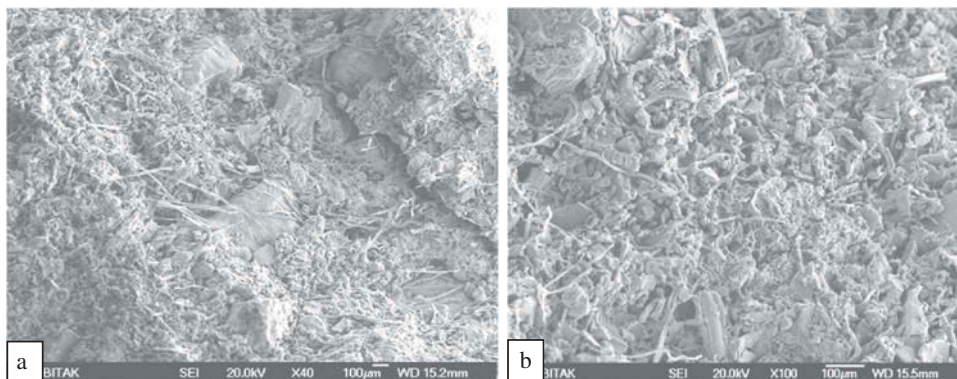
Figures 12a and 12b show the microstructural features of the 2nd region of lichen thallus-roots with immersed

and elongated roots penetrating the grains and porosity sites. The SEM micrographs indicate a network of lichen-algae roots, deep in the structure, covering the grains and penetrating through the voids, pores, and channels. These roots were within a 2 mm thick evenly-covered area, some of them reaching 400–500 μ m in length. Considering the past centuries of exposure of the foundations of these stelae to environmental factors, the rate of growth for lichen roots-thallus is extremely slow and getting even slower as the stone ages, as indicated in the relevant literature (Beschel 1961). It should also be noted that lichens are used in the archaeological dating method

Figure 12. Micrographs of the 2nd Region of lichen roots.

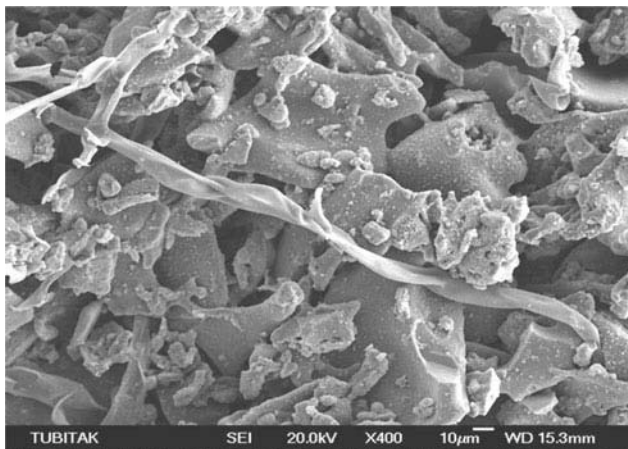
Figure 13 shows such lichen root thallus penetration through the grains, pumicious matrix, and aggregates. Enlargement of voids and cavities between the grains and aggregates and the thallus forcing its way, growing, and extending toward the more porous path is distinctly demonstrated in this SEM micrograph. Overall entanglement of thallus with the grains and aggregates, and the resultant microstructure resembles a kind of moderate reinforcement among the grains, making the whole structure coherent, tough, and lasting. Lichen

Figure 13. An enlarged SEM view revealing lichen penetration and loss of cohesion.

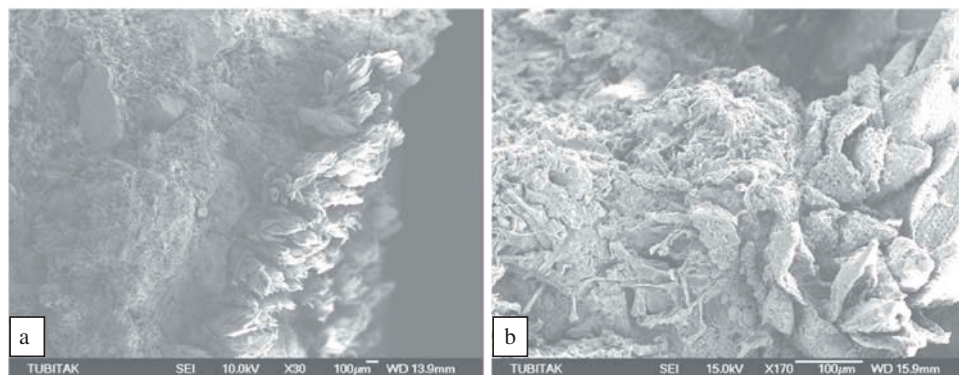
The lichen surface region of a stele is seen in the SEM photomicrographs in Figure 14, showing a variety of bioorganisms, such as moss with leaves exceeding 500 µm in length, and a fungi-like appearance all over the surface. As for the preservation and conservation of lichen-covered stones, there is an ongoing debate as to whether cleaning and mechanical removal of lichens or leaving them as they are is the right direction. Lichen removal from tombstones, sculptures, and monuments is known to be practiced widely even though it can damage the structure. In most cases, the thallus forms a reinforcing network within the microstructure, and its removal may cause severe damage to the surface. Particularly for surfaces covered and colonized by endolithic lichens, mechanical cleaning is not favored since removal of the thallus leaves the surface highly

Figure 14. SEM photomicrograph of 3rd Region of lichen-surface interface starting from the surface.

porous and more open and vulnerable to environmental effects such as acids and moisture. (Lisci, Monte, and Pacini 2003). The SEM micrographs clearly demonstrate this fact and show a very porous microstructure and intact dangling grains and fragments. In this regard, minimal intervention should be considered until extensive in-depth investigation into the exact role and function of bioorganisms is fully understood and documented (Pinna 2014).

Full assessment should also be done to see if the lichens are acting as passive protective shields (or “umbrellas”) against the harsh environment of Ahlat and Lake Van. It is also known that there is an ongoing project on the mechanical cleaning of lichens from the Ahlat stelae, though not much information is available

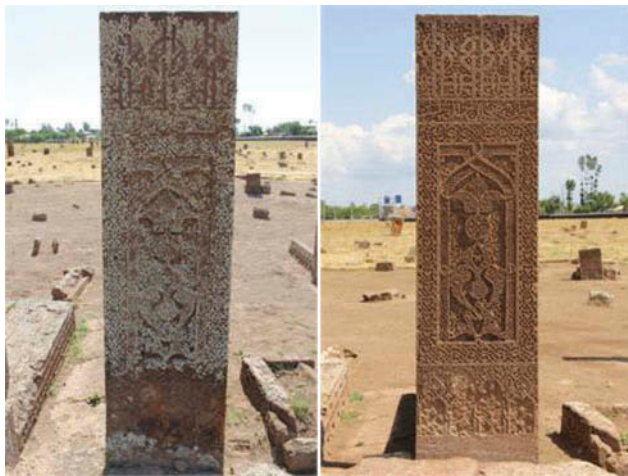
Figure 15. A view of a stele recently cleaned. Left: Before the cleaning; Right: After the cleaning (Source: http://www.eskiahlatkazisi.com/foto_gallery/LIKEN%20TEMIZLIGI/default.htm). © Eskihlatkazisi.com. Reproduced by permission of Eskihlatkazisi.com. Permission to reuse must be obtained from the rightsholder.

yet (only a series of photos on the resulting mechanical cleaning of stones as given in Figures 15 and 16). The mechanical removal of 5–7 mm of lichen seems to uncover the finely carved surface of the stele and the exquisite craftsmanship reappears following such treatment (Figure 16). However, it should be kept in mind that these monuments are still in the same open atmosphere of Ahlat town and Lake Van, and are fully susceptible to lichen recolonization. In this sense, repeated cycles of mechanical removal of lichen layers might erase certain characteristics of the artistic appearance of the motifs, inscriptions, and ornamentation.

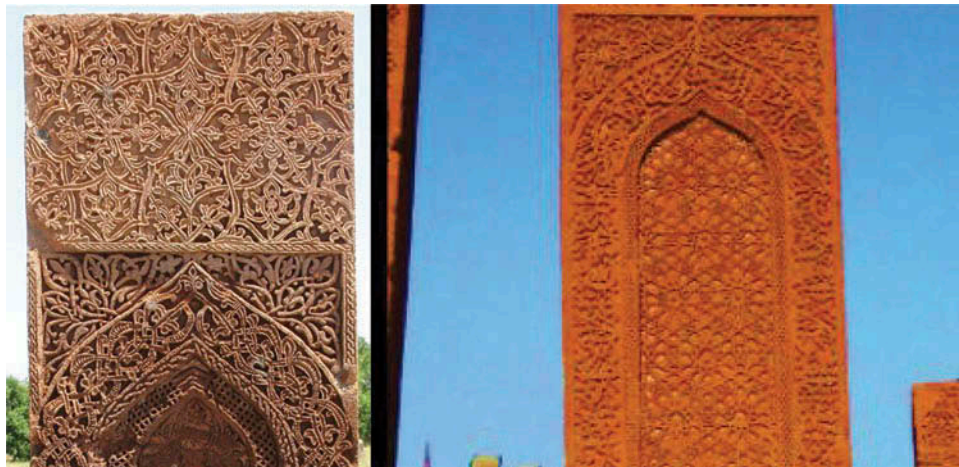
Figure 16. Cleaned surfaces of tombstones.
