REHABILITATION OF ARCHITECTURAL HERITAGE
“A DESIGN ANALYSIS OF A REHABILITATED TRADITIONAL TURKISH MANSION
IN BERAT/ALBANIA AND ONE IN SAFRANBOLU/TURKEY”

MASTER THESIS

ANKARA-2021

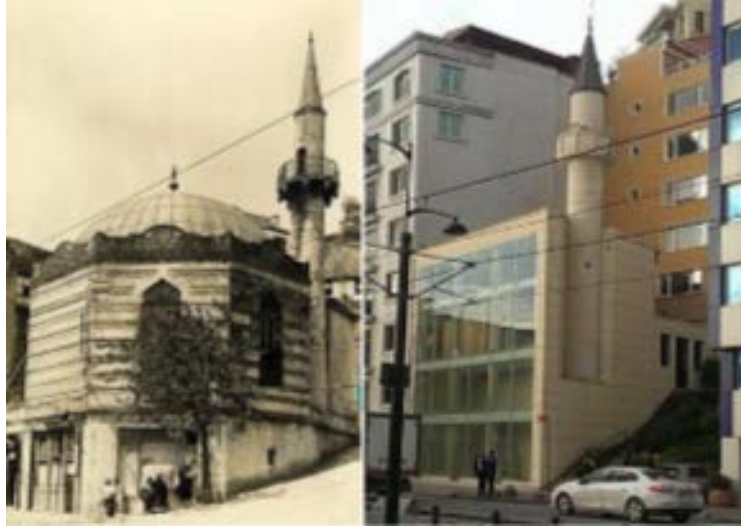
The second building was built in 1591 in Beyoğlu Fındıklı/Istanbul by Süheyl Bey and Mimar Sinan. The mosque, which once had an octagonal plan and a dome, in 1958 had to be demolished as there was a necessity for a road expansion. What was left of the building was considered and restored to be used as an office building. (Tarihçi Prof. Dr. Nurhan Atasoy for hurriyet) Although, by the accordance of the No.2 Regional Protection Board, this building’s only function could be that of a mosque. The outcome, of what once was a beautiful octagonal building, is seen below.

Image 2.4: Mosque in Beyoğlu Fındıklı

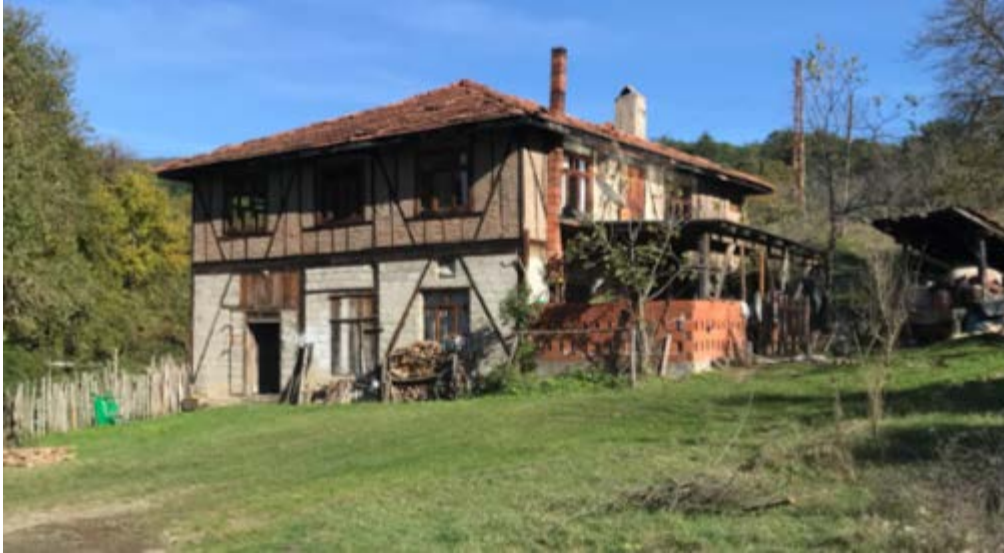
Image 2.5: Konak found in the Turkish village Mengen, photograph taken by Sara Fishta, 2018

The picture above was taken on the road to the Yedi Goller, a forest in Bolu, where a valid example of a Konak house is shown. The beauty of this konak's structure is that there is no plaster put on the exterior walls and this helps identify the construction methods even from a distance. This gives us the chance to evaluate the building by afar. On the ground floor the wooden diagonal elements are used as per strengthening the connection between the mortar and the bricks. This connection method also separates the structure into different smaller parts, a main detail that is healthy for the building in case of earthquakes.

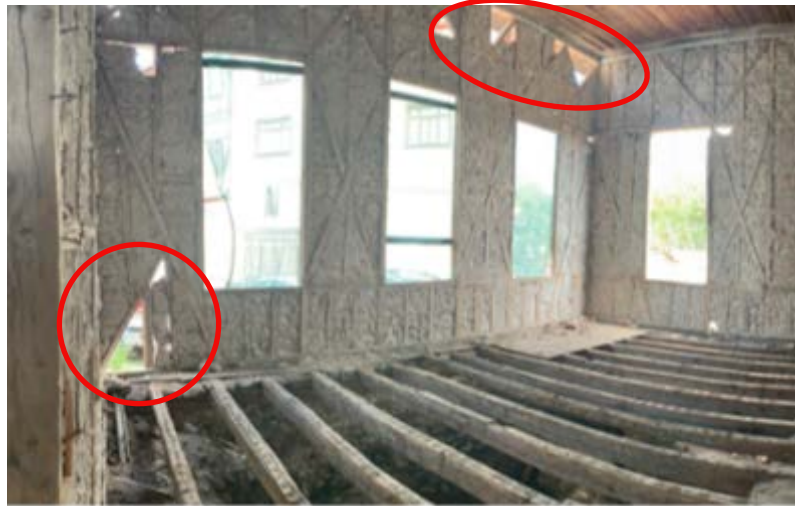
The same method is shown as an example below and it is that of an old konak found in Safranbolu. It is understood that this building, even though it is over 70 years old and badly damaged (source: asked the neighbors), the core of this structure is still standing tall. Thanks to these details it is possible for us, as interior architects/ architects/ constructors to have the chance and bring this building back to life while not only using its core but also respecting the original design and using local materials.

Image 2.6: Safranbolu, used to be an old house, its waiting to be restored into an elementary school.

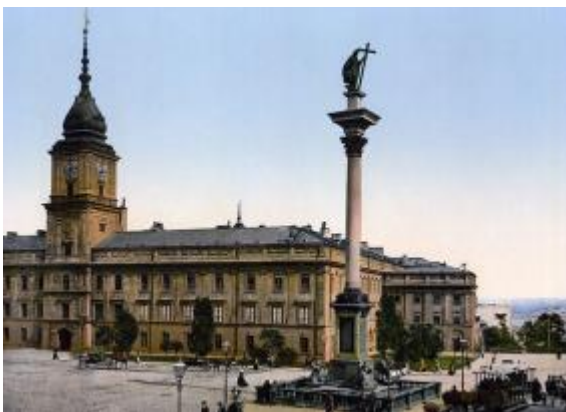
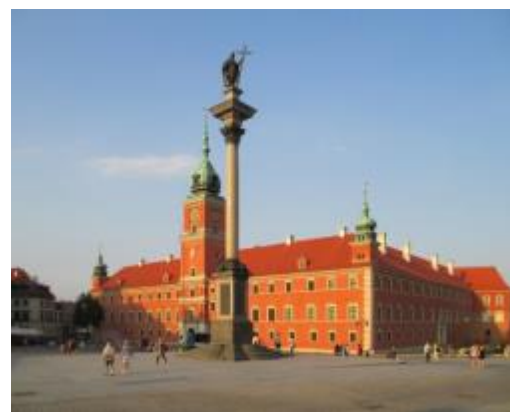
BEFORE

AFTER

Image 3.1: Royal Castle of Warsaw

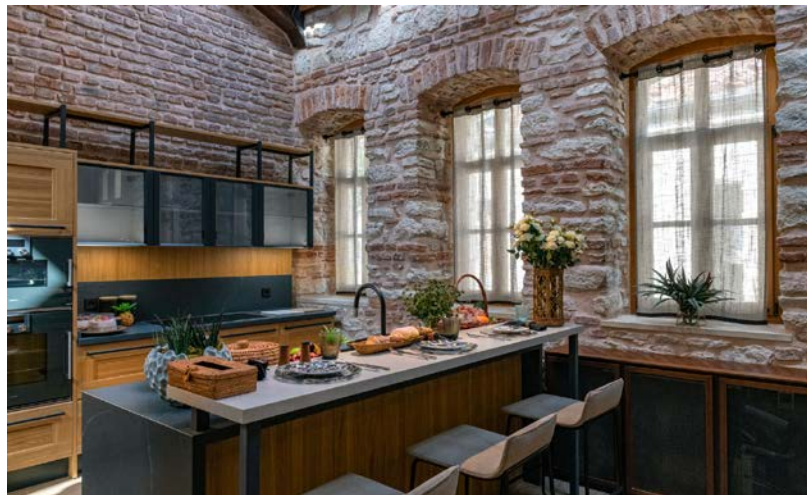
This can be seen on the combination of the rustic kitchen cabinetry harmonizing with the structure. When it comes to the electricity, adding new outlets, new tv cables, new lighting elements and so on, the approach that the designers chose was to layer to cables on top the brick walls, bringing like this a more unique feature to the design without even ruining the structures originality. (Büyük Yalı Loft, Istanbul, Berna 2021)

Image 3.3: Mutfak, Büyük Yalı, Istanbul

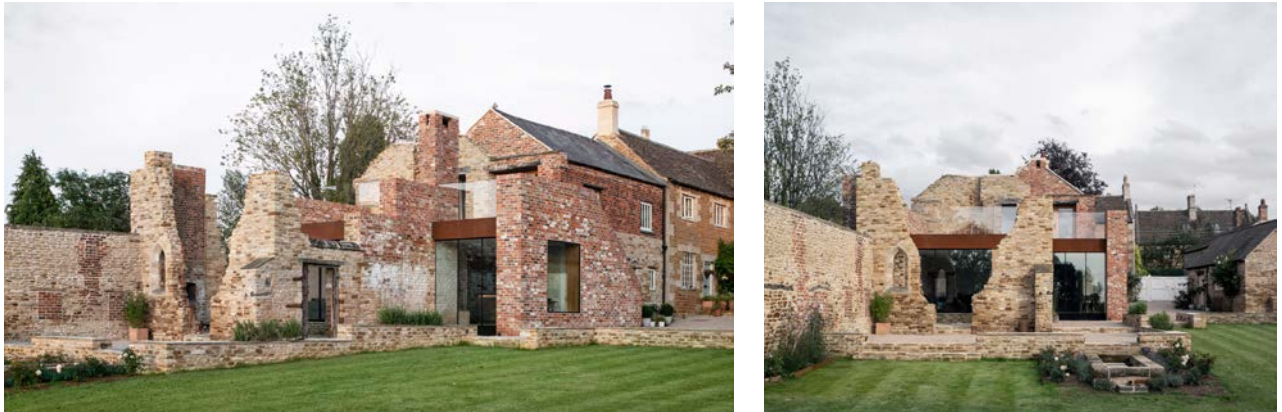
Image 3.5: The Parchment Works House, UK

The one example found above is a 17th-century parchment factory ruins' that were used as the base and the main concept of the architectural design of a contemporary house for a retired couple. Even-though the clients brief asked for the walls to be demolished, the architectural studio suggested to design within the walls and take advantage of the open spatial plan. (Will Gamble studio director, DeZeen, 2013) As seen in the pictures below, the architect tried to use and protect the fallen walls as much as possible, so much that they did not touch most of the exterior walls. "It has real charm both historically and aesthetically. It was very much part of the character of the building as a whole and therefore we felt strongly that it needed to be preserved and celebrated." Will Gamle added. (DeZeen, Lizzie Crook, 2013)

The need and desire to preserve the heritage of this building is evident also in the interior of the house which is filled with materials that were found on the site. Elsewhere, five-metre-long oak beams found outside were also cut down to be create lintels for the extension's doors and windows which was paired with contemporary weathered steel and wood detailing. It is noticeable that the concept behind the interiors was to go for an honest palette of materials that celebrated the architecture of the cattle shed and the ruin. The architect tried to preserve the character of the ruins as much as possible by leaving most of what was already there uncovered and untouched.

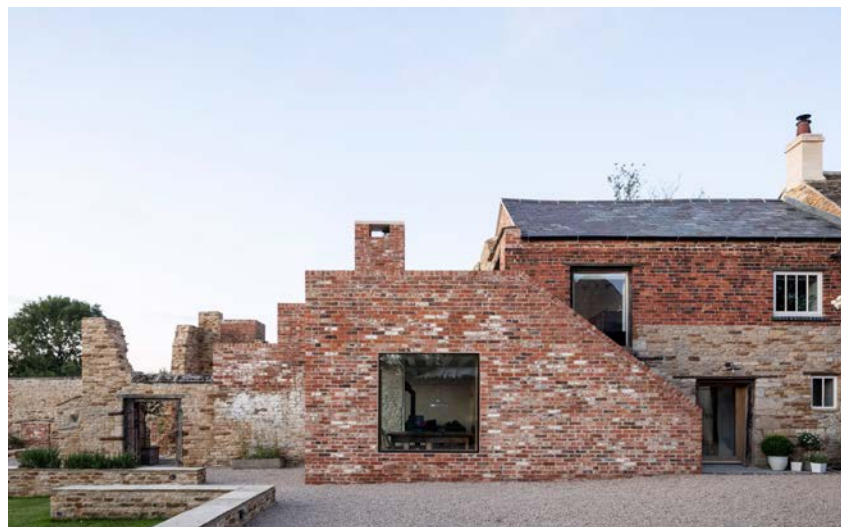
Image 3.6: The Parchment Works House, UK

The building is single-storey in height with an added roof storey on the bedroom area, it has a strict stepped form and more than half of the pre-existing ruins have been used. When they were designing, the studio firstly thought of filling up the ruins with new materials but soon after decided to protect the original ruins and only infill half of it. As seen in the pictures below the old and new material harmony can be noticed on the eastern side of the building. The original brick structure on the bottom floor had only the spaces filled with the new materials, whereas the upper levels the new brick structures were added. This gave a different life to the building while highlighting the importance of the original architectural structure. By doing this they used the preservation principle on when rehabilitating a building, thing that raised the value of the property. (DeZeen, Lizzie Crook, 2013)

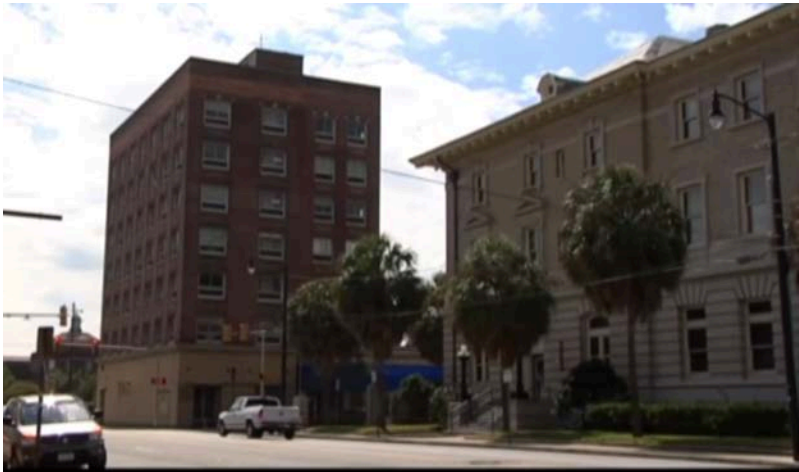
If a building is considered as a heritage one, it is protected by the law and yet it is in great danger of demolition, what will happen to the longevity of this structure? Is there any way for it to be reconstructed, rehabilitated and preserved? A great example of this would be the 96-year-old building attached below. This structure had been used as office headquarters for the company trust of Florence hall during its longevity, but since it had been abandoned for over 30 years, the leaking happening in it “was the beginning of the end” says Ray Reich, the downtown manager of Florence City.

Image 3.11: Florence Trust Company Building/USA

The solution that the university and the preservation community offered was to use the core of the building for the new medical school of Francis Marion University. As seen in the pictures below, the moisture has penetrated the walls and the mold has damaged the structure deeply. Nonetheless, the final decision taken was to destroy the building and construct a new healthier one.

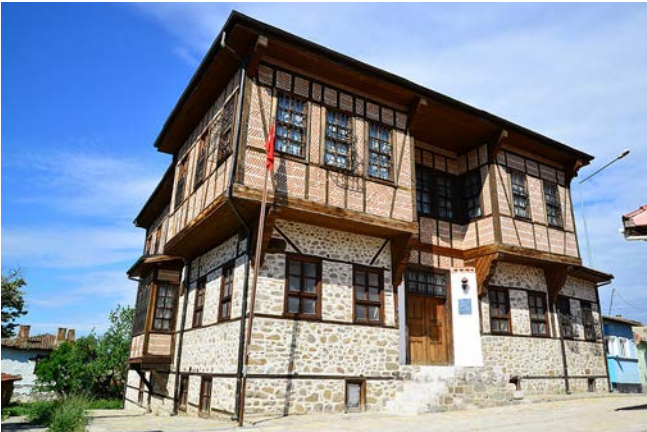
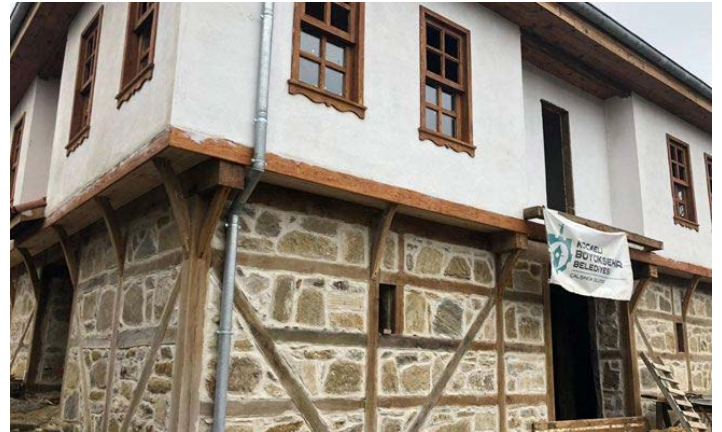
The konak’s structural design is characterized by dense frames of modular elements and is commonly based in a masonry basement, property which soothes the actions of seismic shaking and protects the vertical structures from contact with moisture. Its framework is done by wooden elements filled with adobe, mixed masonry or bricks, thing that stabilizes and reinforces the structure as much as makes it lightweight. External coatings are usually made in plaster or sometimes, differing from the geographical position of the mansion, in wooden pan-

els. (Cengiz Bektaş, 1996)

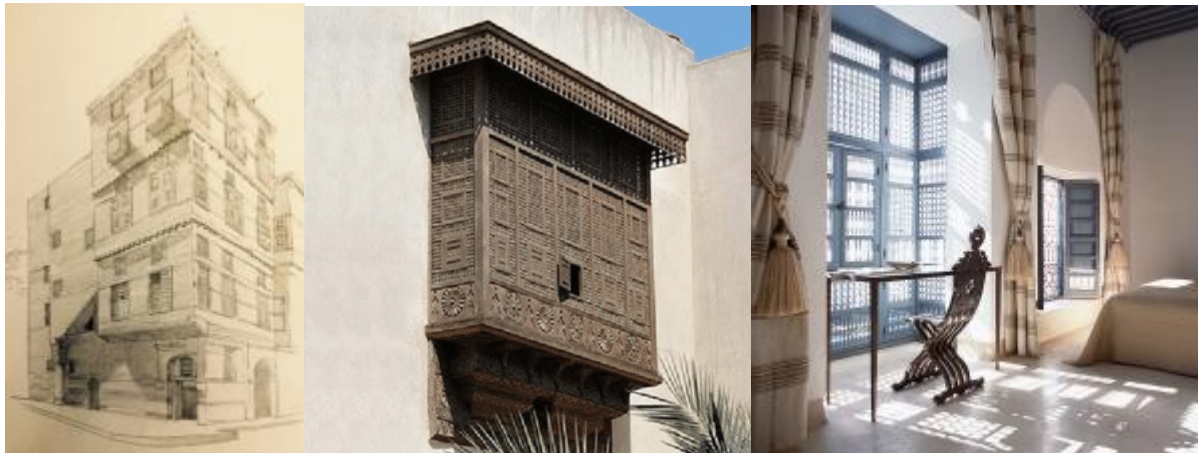
Drawing 4.2: Serena Acciai (left)

Thanks to the wooden structure, it is easy for the window openings to be managed according to the size desired. The window sizes are usually in a 1/2 ratio which makes it be a rectangular size positioned vertically on the facade. The windows are made entirely of wood and summer houses usually have skylights as well as bay-windows, a most unique type which is seen widely in the upper floors. The bay-window, also known as “cumba” in Turkish, is one of the most inactive elements of the traditional Turkish house. Regardless of the roughness of the facade, the bay-window smoothed the structure, provided the opportunity to intake much more natural light in the interior, and transformed simple ordinary rooms into square quadrangles and the overhang of the window usually differs from 100-130cm. (Çobancaoğlu, 2007)

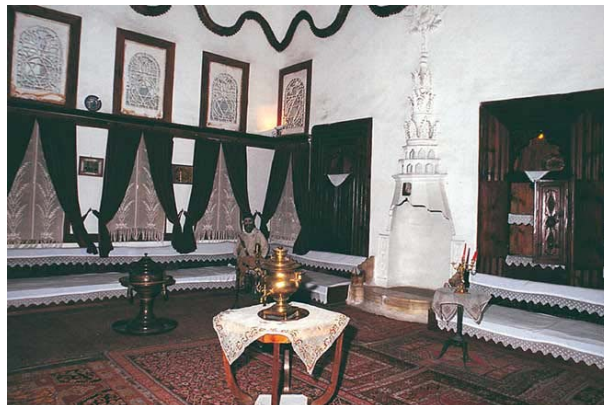
Image 4.5: Latifoğlu Konağı Müzesi, Yozgat/Turkey

The floors are timber-made and are floating floors, detail which was done between the 17th and 18th century and was seen in the modern architecture many years later. The boards are positioned without any adhesive or nail for the purpose of investigation and intervention, this also allowed for the mansion to have natural ventilation and enabled the building to breathe in humid climates. These specifications brought as a conclusion the prevention of condensation and moisture in the rooms. The Turkish house's interior decoration received more attention where more rooms and sofas have been embellished. Interior décor, stoves, and cabinetry have all used stone. On stone, stylized floral motifs, figures, calligraphy, and geometric moldings were created. Large-headed nails were used to decorate cabinet doors, ceilings, and flowers in metal decorating. (Ministry of culture and tourism, Republic of Turkey, 2014)

This is a great example of architectural understanding that the Ottomans possessed. With the simplicity of the timber floors, the ornamented wooden ceilings were the elements used to make the contrast in the Turkish House. The most common decoration style is the ceiling designed by making triangles and hexagons within wooden staves (Bektash, 1996, 56).

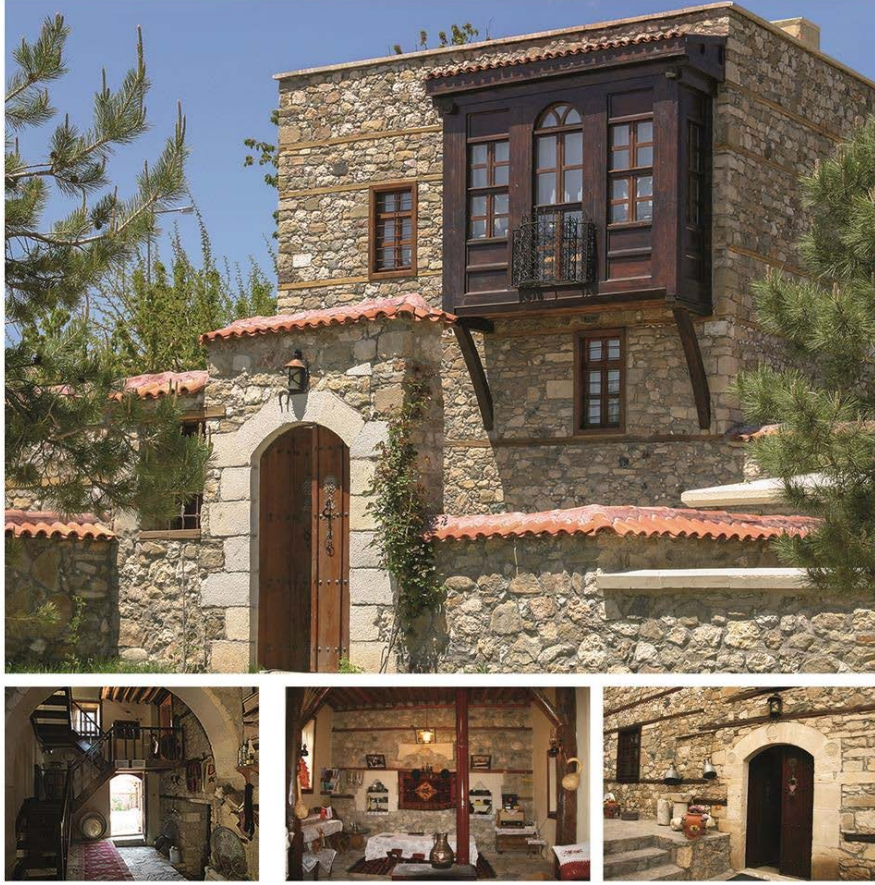
Image 4.8: Harput Evi Örneği/Turkey

The look of central and eastern Anatolian village settlements is characterized by adobe structures, single-story mud brick homes, and flat roofed houses. Stone masonry buildings predominate in stone-rich areas of the same geographical regions. If these stones are extracted from the quarry, they are soft and easy to treat. Over time, they harden and gain strength. Depending on the climate zone of the Turkish house, the lower floors of two or three-story houses have an introverted character that is effectively insulated from the elements. As a result, the bottom floor's exterior walls are often built of stone or a mixed adobe main wall with stone masonry supports. Usually the window does not open to the exterior, however a mezzanine facing the street can have its window opened. The carvings and reliefs on the facades and numerous decorative features on the stone walls grab attention. These stone houses are favored by individuals in both cold and very hot climates and this is because of the freshness the stone gives during the hot summer days. (Bektash, 1996)

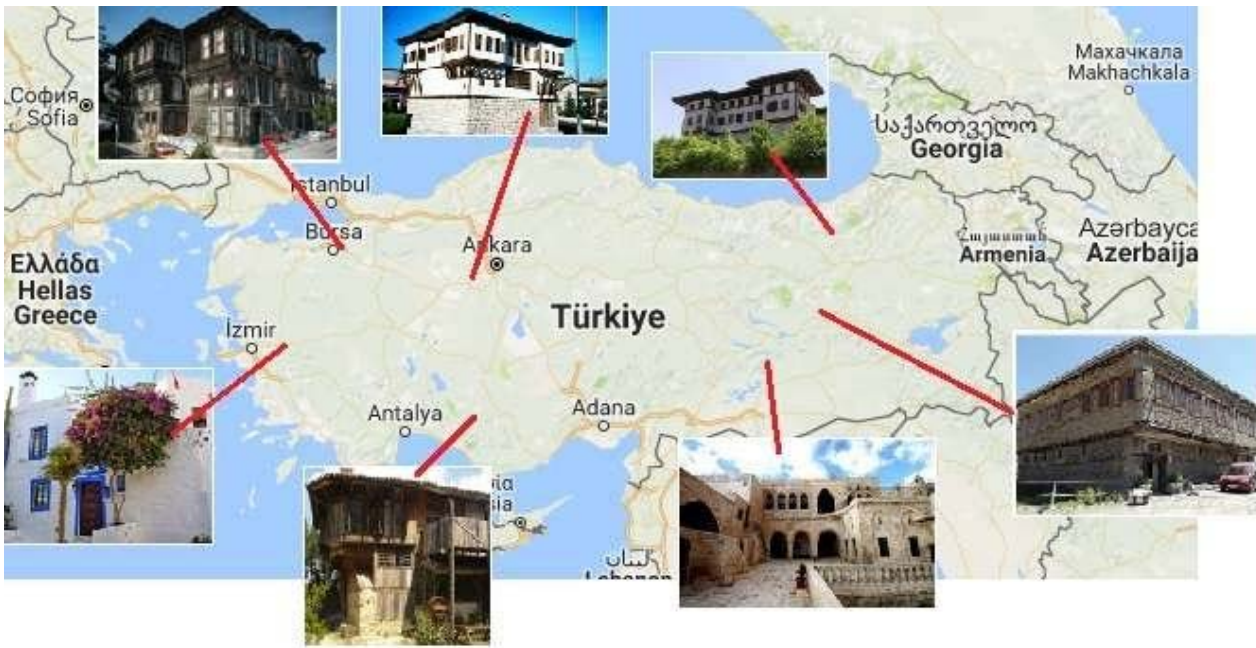
Image 4.10: Traditional Turkish Houses in Anatolia According To the Regions

The timber/wood structures are either erected on a shallow foundation stone wall with mortar or on big cubical corner stones in timber frame buildings. If it was erected against a stone wall, the skeleton was finished with the major pillars, intermediate pillars, side braces, window lower and upper beams, and floor release beams, which were installed on the remaining wooden beams put against the wall. If the property has two or three levels, the process is done on each floor in the same manner. (Arseven, C. Esat,1975)

As a practice, big processed stones removed from a nearby ancient ruin were used as cornerstones in numerous dwellings. Furthermore, engraved inscriptions, column bases, statue bases, and cornices were utilized as cornerstones. Mud brick, brick, and stone were used as skeletal infill in wooden frame buildings in various locations, and in other cases, they were left empty and thin wooden laths were fastened to the interior and exterior and coated with lime mortar. Baghdadi plaster is what the Turkish call it. The interior surface of summer cottages, such as grape homes, is covered with wood, but the exterior surface is left open. These holes were filled with thin flat stones in the specimens from the Black Sea region. (Arseven, C. Esat,1975)

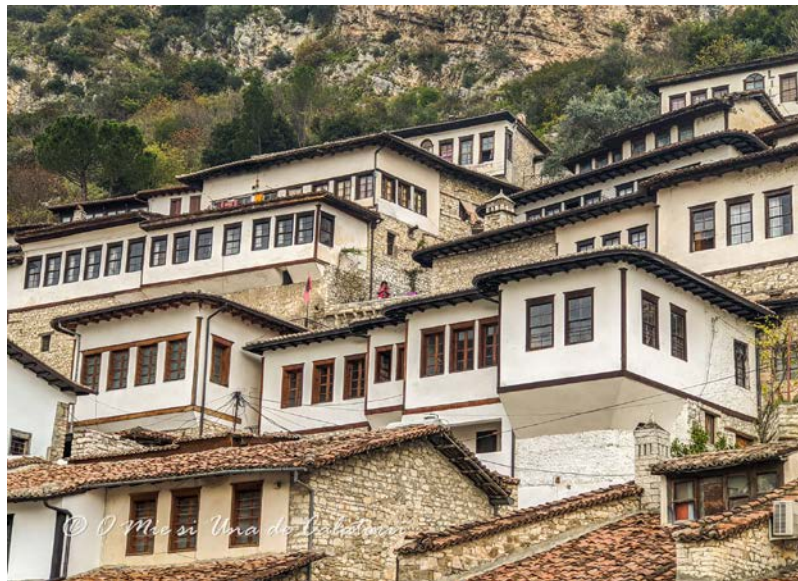
Image 5.5: Berat /Albania

As it can be seen from the pictures above, this hotel is a three-story height mansion where the ground floor is made out of mortar stone and the upper floors are covered in white plaster with a contrast of wooden windows, a typical konak which has been beautifully rehabilitated and preserved with the original elements. Since the houses of Berat are located on the hill and look as if they are positioned on top of each other, it is possible to enter the hotel only by reaching the stair shortcut which opens to the plaza, or make a little detour and walk up the hill. The entrance is positioned on a landing area from the narrow roads of the old city where there are two other different house entrances found and one exit to allow the passage to the upper konaks. In the pictures below the entrance can be seen that it has been changed from the original, but has kept the same figure, color and shape from the original design. The door entrances located in this area are usually oval on the top, this is a detail with characterizes the knocks located in the Balkans. Usually the Turkish konaks have sharp edges and straight lines, the oval element is borrowed from the byzantine architecture which is still alive in some old Albanian homes.

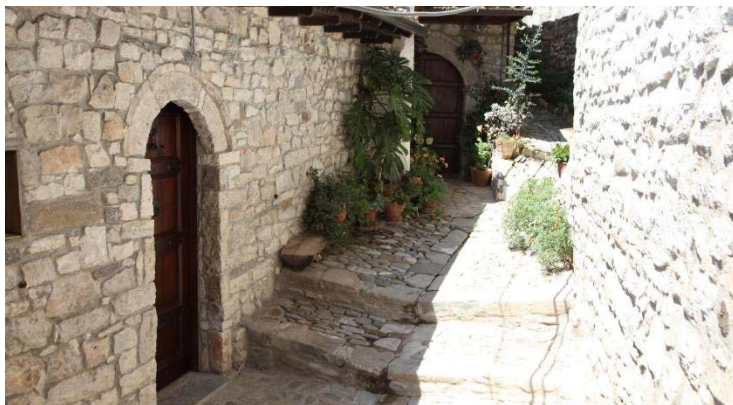
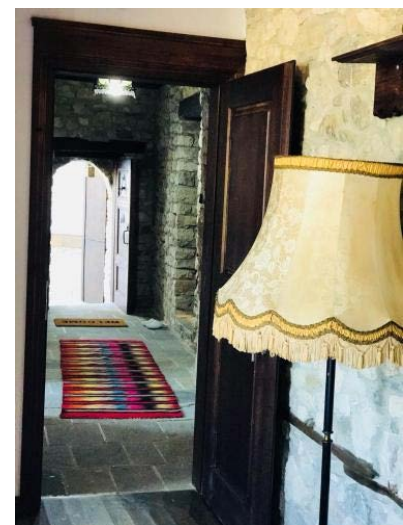
Image 5.6: Xheblati Hotel, Berat /Albania

As one enters the building, they are welcomed to what once used to be the “hayat” of the floor but now is being used as the reception where the tourists are welcomed. This hotel has 8 rooms, which are all positioned on the upper floor, a restaurant positioned on the basement floor and a terrace which is built just adjacent to the restaurant. The rehabilitation this hotel went through is a great example of preserving history and reusing it for a new and profitable purpose. Not only the architectural elements of the buildings have been preserved precisely, but

also some of the furniture and textile cloths were inherited from the ancestors. The rug seen in the picture above for example, is one of those cloths that has been used for 4 generations and is still usable nowadays.

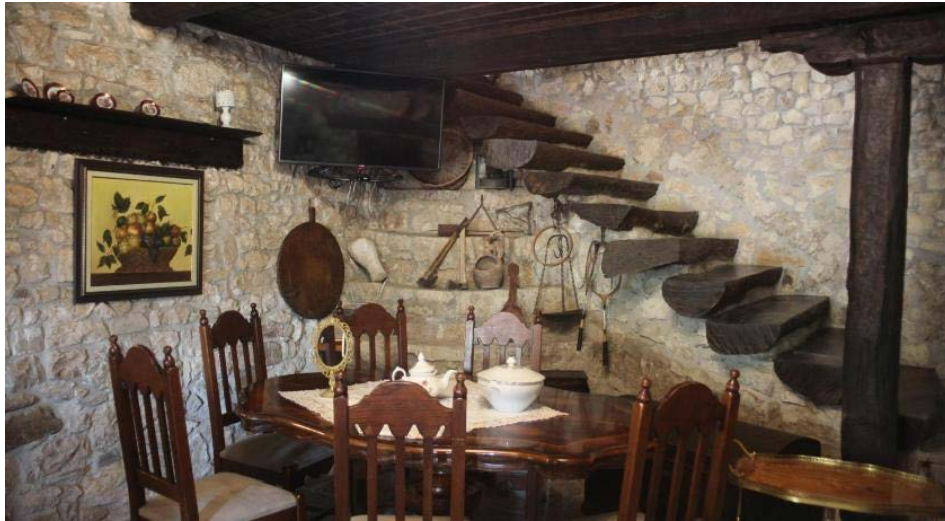
Image 5.7: Xheblati Hotel -1.kat, Berat /Albania

The reason why this konak is so well preserved is because people have been living in it for many generations and the house has been constantly taken care of. The update that took place in it is usually the usage of the electrical outlets and the renovation of some old partition, such as the stairs. The stairs that bring you from the reception to the closed restaurant have been rehabilitated and wood partitions from the site of the original structure have been reused and painted. The same has been done with the infrastructure. To reinforce the structure beams and columns of wood have been added and painted. The walls have been rehabilitated with new pieces which resemble the original ones. This is in contradictory with the article 12 of appendix A which claim: (Replacements of missing components must be harmoniously incorporated with the whole, but must be distinguishable from the original at the same time, so that the reconstruction does not falsify the artistic or historical facts.) Nevertheless, the harmony that this chaotic stone wall has brings a smoothness to it. (Venice Charter, 1964)

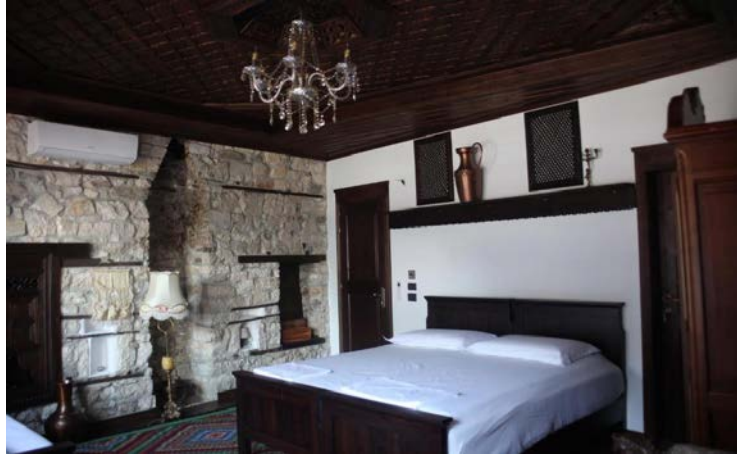
Image 5.8: Xheblati Hotel Room Sample, Berat /Albania

As mentioned in the sections above, in the Turkish Traditional Houses a fireplace would be found in each and every room of the house, not only in the big oda, and the ceilings would be decorated with wood to show the hierarchy of the rooms. Even-though it has been updated to the “modern” lifestyle with the elevated bed, the air-conditioner, the self-standing light and the electrical outlets, the room above is a great example of the Konaks understanding of life-style.

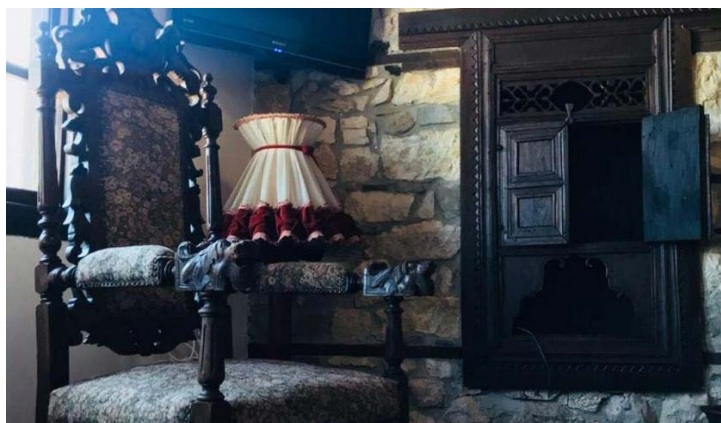
Image 5.9: Xheblati Hotel Room Sample, Berat /Albania

The wall cabinet as well is a small detail that used to be famous in the Traditional Turkish architecture where the most intimate belongings would be put and “hidden away”. To bring the outlets though the walls it as necessary to open up that wall and then close it up again.

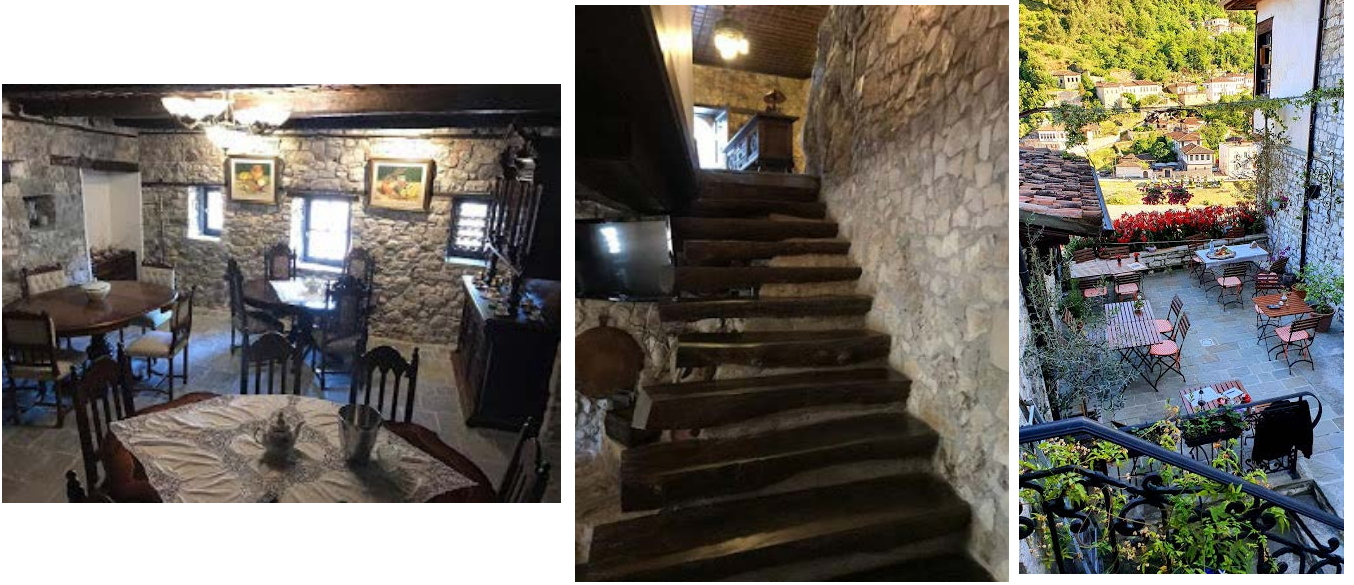
Image 5.12: Xheblati Hotel, Berat /Albania

The function of the barn has changed tremendously. By being used for storage and being turned into a lovely restaurant brought a lovely feeling to the hotel. Originally, if one wanted to go to the barn would have to leave the building through the cardak, and then enter it and this was because the original stairs were located only on the outside. After the renovations the building went through, the necessity to connect the new restaurant with the entrance raised, thus the opening of the entrance walls to create the stairs that would connect the ante with the restaurant was the solution. The approach made for the construction of the stairs was to use an original load bearing wall and put on it original slabs found to the site and thus create an authentic staircase with original pieces.

Finally, the çardak, which once would be used as a balcony and as the only pathway to go to the barn, is now the most lovable space of the hotel. With a lovely view towards the Osumi river, the client's favorite spot is the terrace. Even though the function of the house has been changed, not much has changed from the original layout. This lovely hotel is a reflection of the history and it is an example showing how the Traditional Turkish house was so visionary.

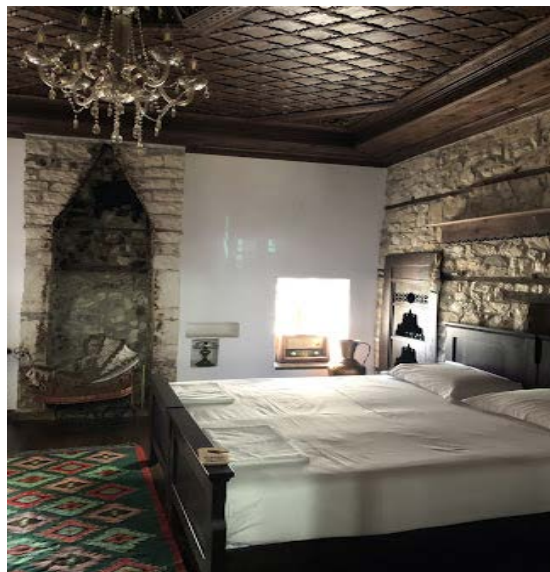
Image 5.14: Xheblati Hotel, Room Sample nr.2, Berat /Albania

The interior walls that have been added in the upper floor are almost all added later. Adding these walls was easier to add the electrical outlets and create more original spaces. Out of the 5 original interior walls, only two have been kept. To highlight the fireplace of the existing rooms, the owner had decided to cover them with the stones found on the site, creating like this a historical yet unique feeling in the rooms. The niches on the side of the bed are a typical element in the interior of the Traditional Turkish house. It would be used as the contemporary use of hidden drawers.

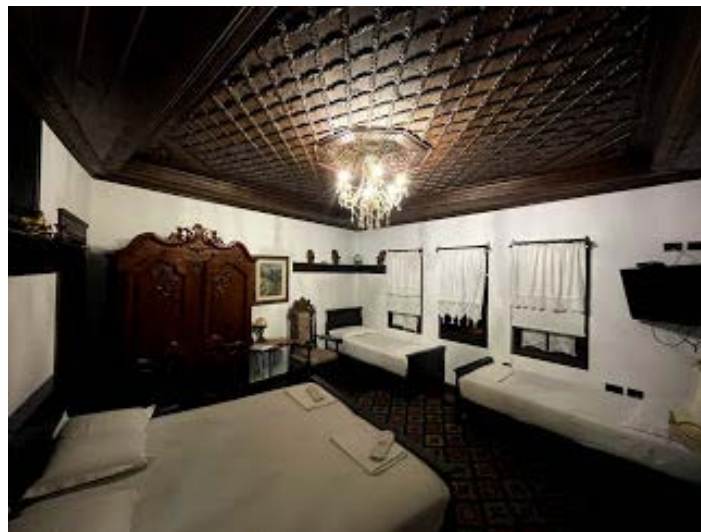
Image 5.16: Xheblati Hotel, Ceiling Sample, Berat /Albania

The interior of the rooms was preserved as much as possible. This can be seen from the detailed on the ceilings and the wooden partitions. The ceilings are original. They have been kept in the most beautiful manner and treated accordingly. The only change that they have had is the paint coat they get done every decade.

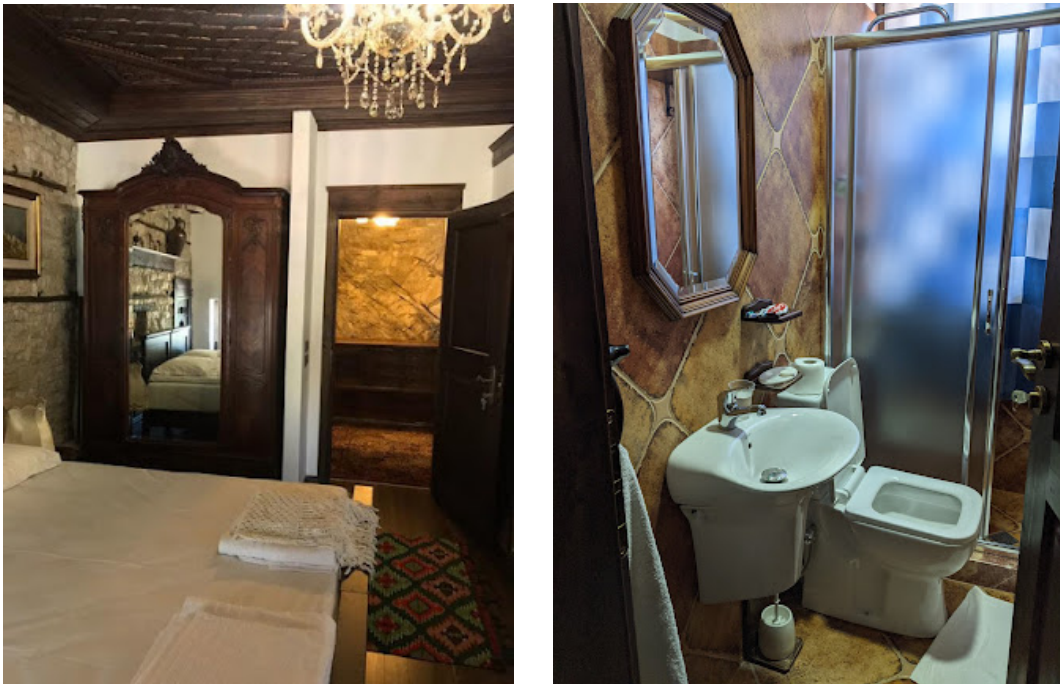
Image 5.17: Xheblati Hotel, Room & Bathroom Sample, Berat /Albania

Because it was necessary to create wet areas for each room, the plumbing project required to open up some areas of the original floors to make the exits of the water. The interior of the newly constructed bathrooms was not the best choice though. What they did was use ceramic tiles, use just any casual sink and wet closet, and a glass partition for the shower, all details that degraded the feeling of originality when staying at the hotel.

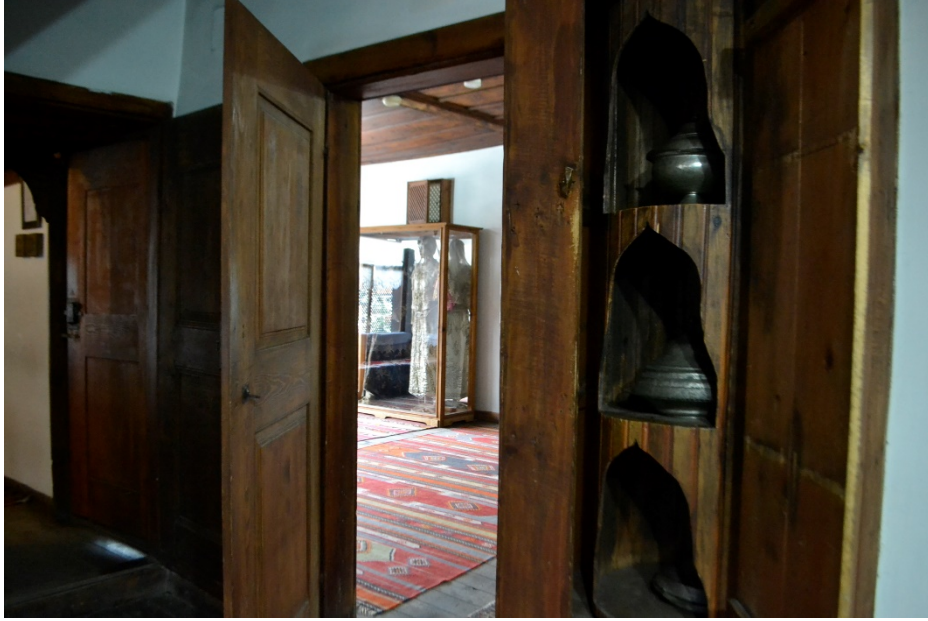
Image 5.18: Kaymakamlar Evi Müzesi Dönme Dolap Örneđi, Safranbolu/Turkey

The original dwelling was built according to the haremlık and selamlık practices, allowing the women in the house to roam freely. Even the food cooked by the ladies were delivered to the males by a Ferris wheel from the kitchen. The Ferris wheel's prepared dinner is placed in one eye, and the woman who places the food knocks on the wood. This is how the person behind the cabinet would know the meal was ready and would turn the cabinet to take the food. As a result, men and women would not be able to see one other. This has all been portrayed in the museum.

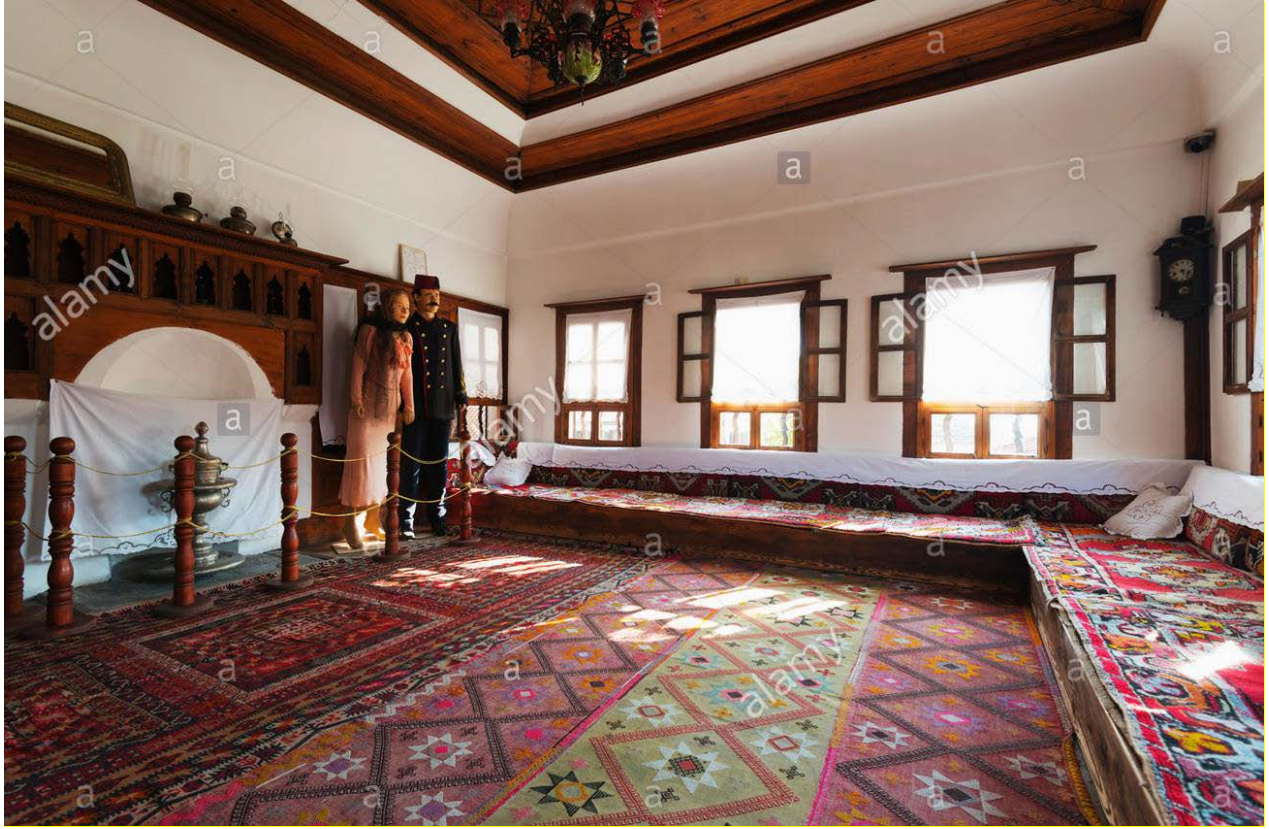
Image 5.19: Kaymakamlar Evi Müzesi Oda Örneği, Safranbolu/Turkey

The rooms on both floors are designed to accommodate all of the demands of persons living in a big family environment. Each room has a sofa, as well as the option of eating at the floor table, sleeping on the floor bed. The house is well-lit thanks to the numerous windows but it was necessary to add the lighting outlets nonetheless. Walnut and pine ceiling decorations are excellent examples of taste and beauty. Traditional materials are used to furnish the Harem and Selamlık's seven rooms and couches.

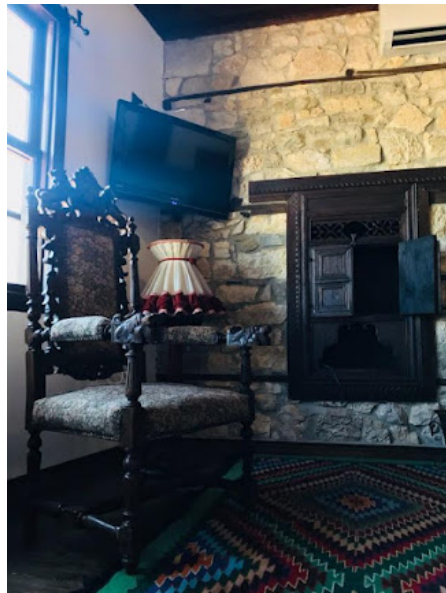
Image 5.20: Xheblati Hotel, Furniture Samples, Berat /Albania

The traditional Turkish houses have relatively minimal furnishings. The multi-functional fittings seen in nomadic tents and functioning for both day and night use are shown as the few fixtures in multi-functional rooms in permanent settlement dwellings (Bektaş, 1996: 110; Günay,1998: 245). Nonetheless, this updated konak has brought in all the furnitures required for the hotel. At the entrance an antique console and an arched shelf is found. In from of it there are two big armchairs which function as a waiting area for the clients. In the barn floor there are 5 tables, four of which are round and one is a openable rectangular table. The chairs used as well as the tables date back to the early 1990s when the konak was first decided to be turned /into a hotel. All of these furniture add a medieval feeling to the room.

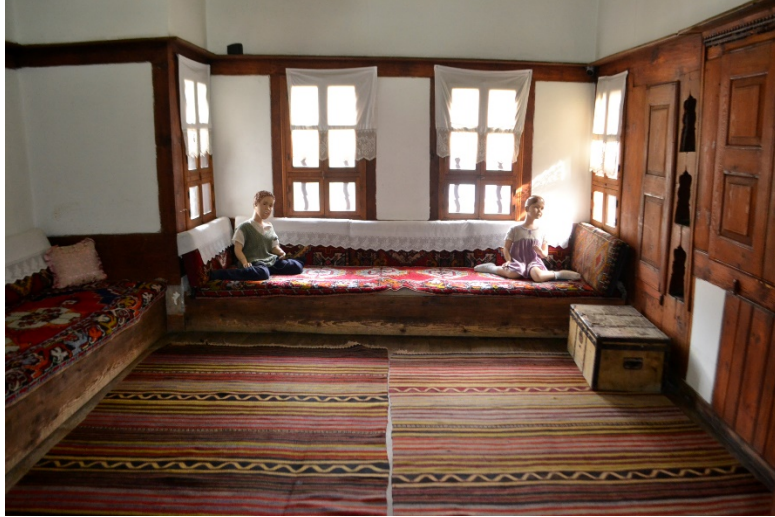
Image 5.22: Kaymakamlar Evi Müzesi, Çocuk Odası Örneği, Safranbolu/Turkey

In the Kaymakamlar house the walls are plain. Vertical, rectangular recesses created from the thickness of the wall can be found in various rooms. The cylindrical niches, which are situated in the middle of the walls in large rooms and are covered with marble on the inside and adorned with plaster or wooden material, are used as lamp stands or flower stands. In this house as well as in the Xheblati house the contoured, wooden cornices that run along the upper level of the doors and windows enhance to the interior's aesthetic richness. In addition to glass sashes, there are wooden bars on the inside walls of the windows. These bars are designed to form small square portions and /are used to obstruct the view as well as provide safety.

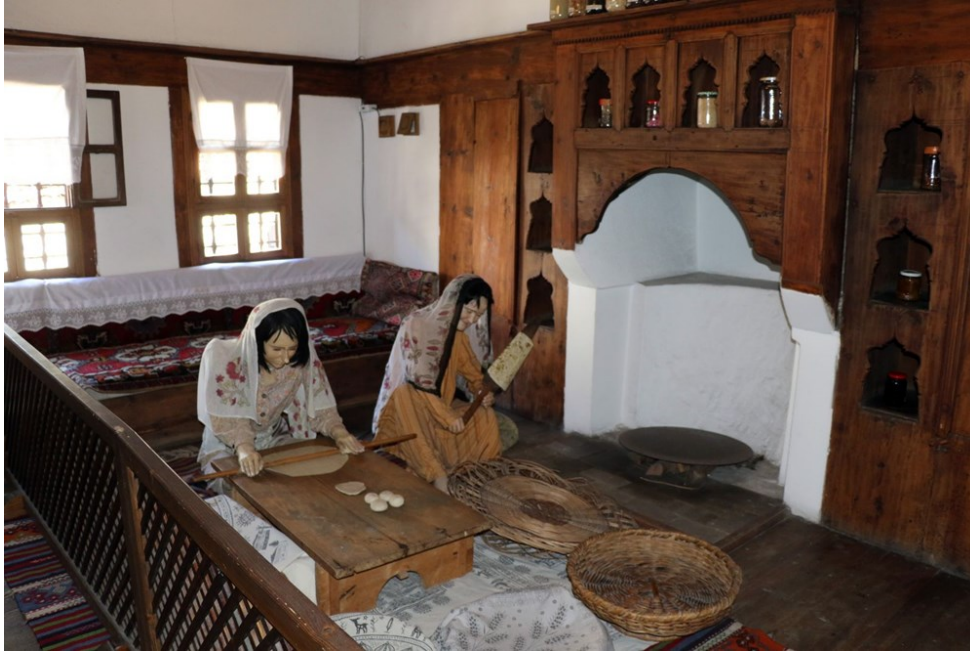
Image 5.23: Kaymakamlar Evi Müzesi, Ocak Örneği, Safranbolu/Turkey

The most basic condition of ceilings is uncovered ceilings, which allow the structure to be seen. C-S curved wooden corbels support the major wooden beams and trusses found in the long span ceilings, where the wooden runners are exposed. In most Traditional Turkish homes, fixed furniture is not present. Moving furniture was utilized, with different tasks requiring different locations in the space. According to the purpose of the oda, the sedir is moved to the edges of the room and the central region is left unoccupied. The structure might be made of wood, stone, adobe, or stone, but the cedar's position in the chamber will never vary. The sedir might be on one or three sides, depending on the size of the space. Sedirs are generally solved depending on the construction and the load-bearing flooring. The most common material used is wood. Sedirs have a width of 75cm and a height of 35cm. To assure seating, the top of the upholstery is covered with a soft cover. Backrest pillows and embroidered covers of the same size on the reclines, soft cushions and breech coverings on the seats all come together to create a complete set.
